Cathedral Trial Plasterwork Progresses

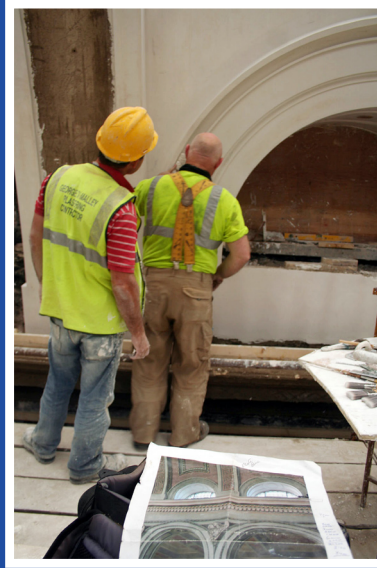
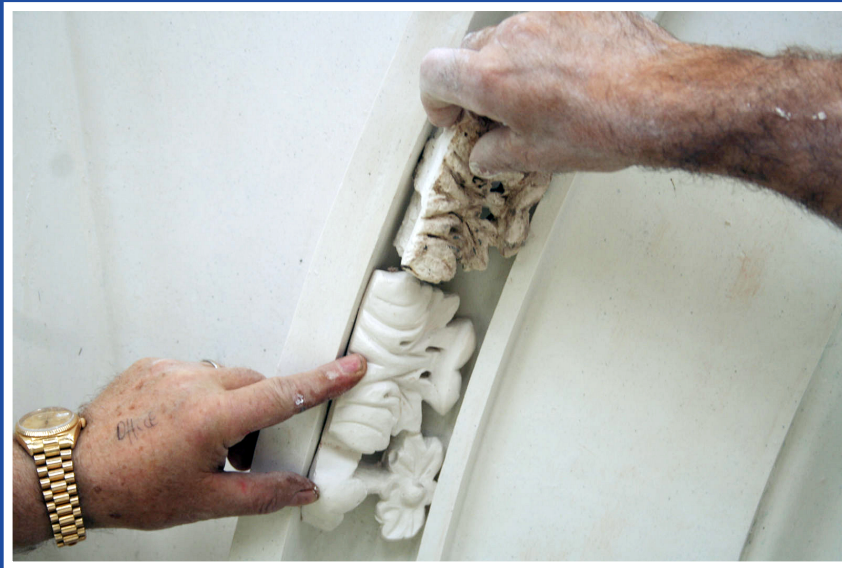
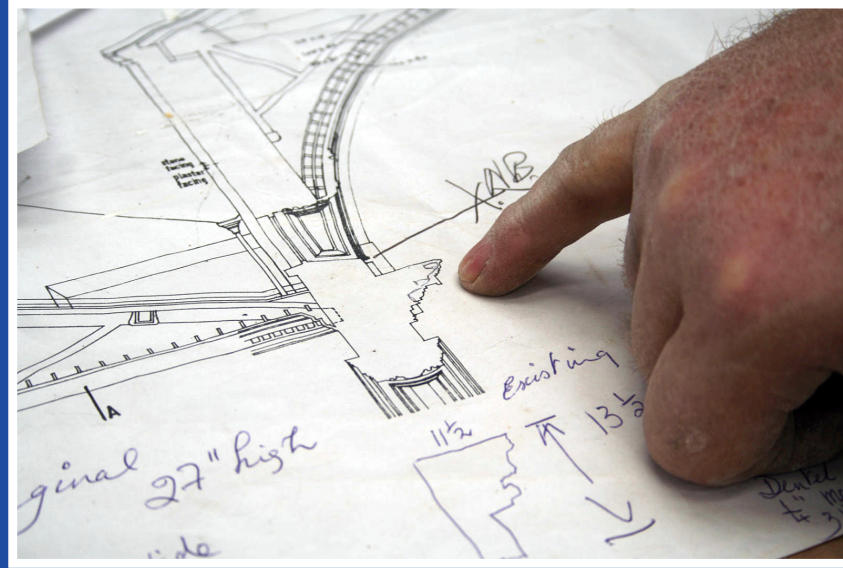
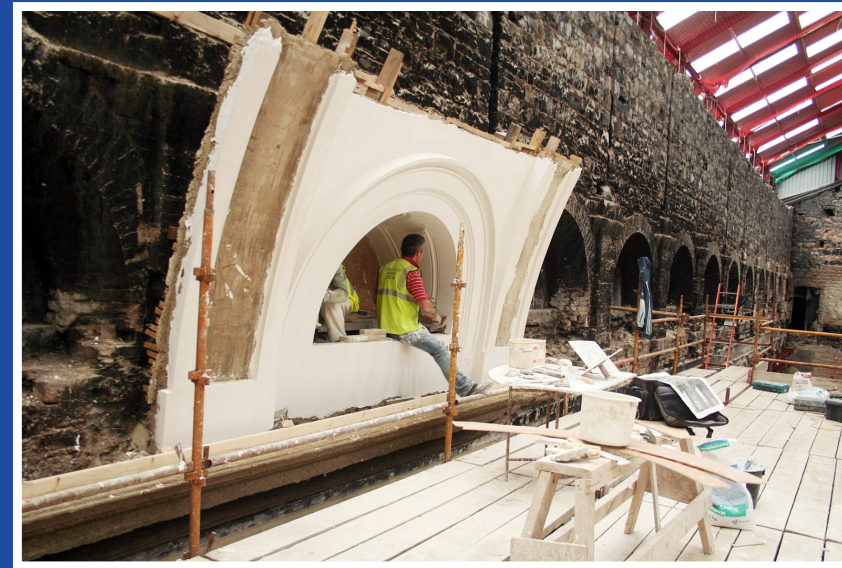
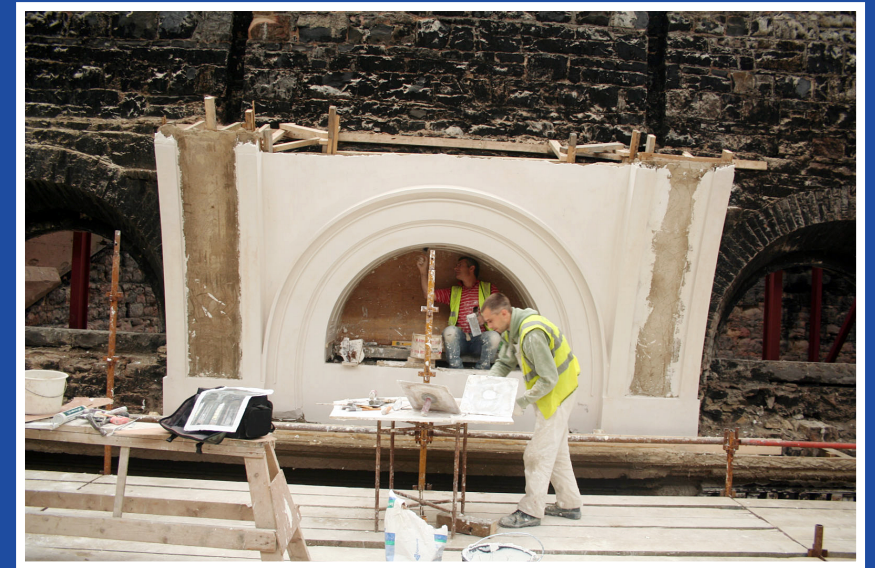
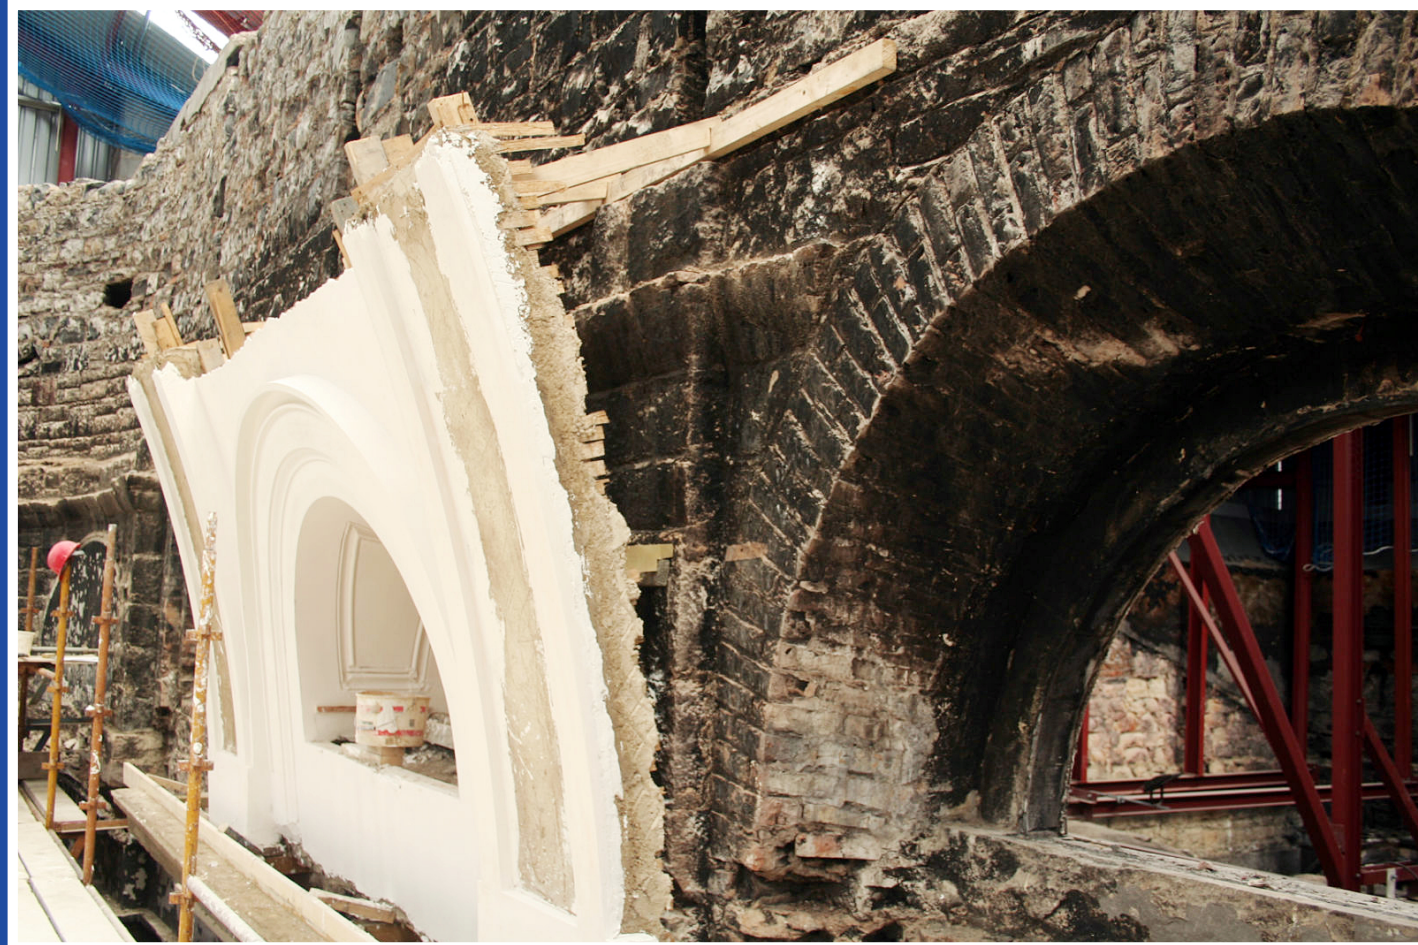
The trial plasterwork was undertaken by George O'Malley Plastering. These pictures show various stages of the trial work carried out on site by the skilled plaster craftsman. The results of these trials will inform the Design Team on how the original plasterwork was executed on site and how therefore to plan for the replacement works and their details.
