# Trial Pillar Replacement

FRAN McNULTY

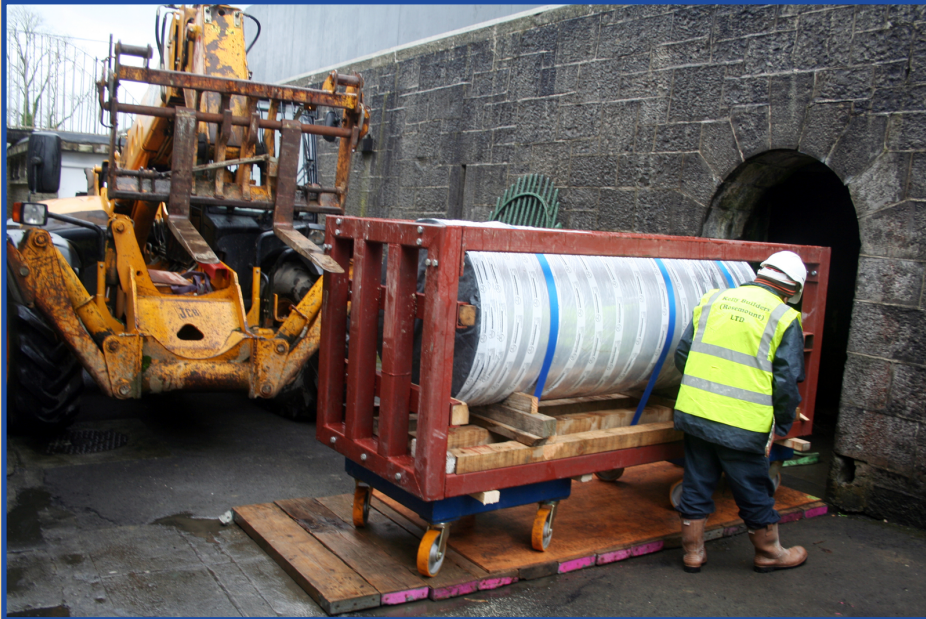
Replacement Pillar arrives and workmen begin to bring it into the Cathedral via the Crypt.

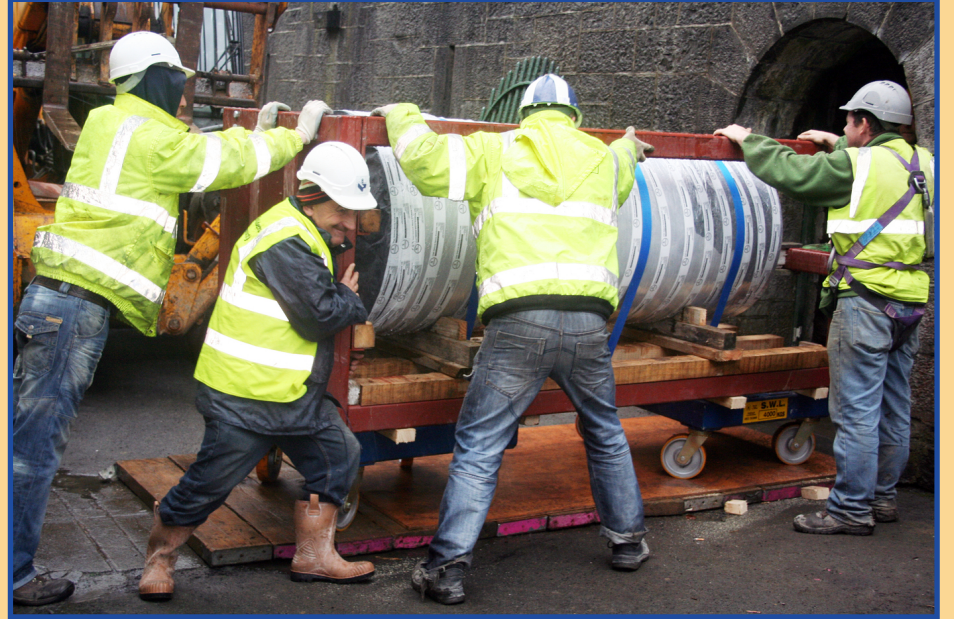
The replacement pillar is wheeled into the Crypt of the Cathedral manually.

The new column is an exact replica. The investigative work revealed the true scale of the damage done to the pillars; the intense heat of the Christmas morning fire has badly damaged the stone and it is crumbling. All of the pillars will have to be replaced, that process alone will take over a year. Project Manager Niall Meagher says the work undertaken by Kelly Bros in the lead up to Christmas has been vital, "it has taught us the condition of the stone, how to remove the columns and more importantly how to install the new ones". Mr. Meagher says "we've learned a huge amount from the investigative works, they also provide a timeframe for the project, we now know that it will take up to fourteen months to replace the columns". Christy Hynes has been on site at the Cathedral throughout the investigative works, "the method used in the 1840's are not much different to what we've been doing for the past few weeks". The replacement column was wheeled into the crypt of the Cathedral manually and hoisted up using

a manual pulley system. It takes around thirteen weeks, for each pillar, from the time the stone is quarried to the point at which it is installed. The scale of that part of the project alone is breathtaking.

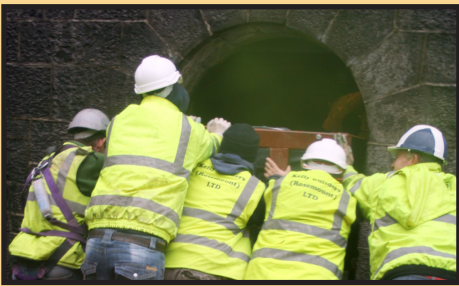
One final push sees the Pillar in!

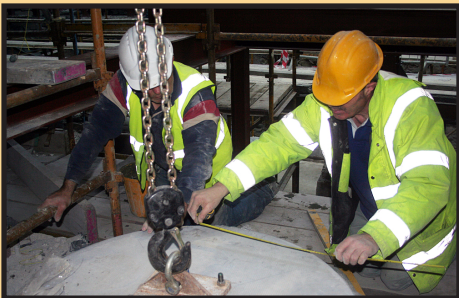
Pillar foundation stone being measured as workmen begin the process of setting it in place.

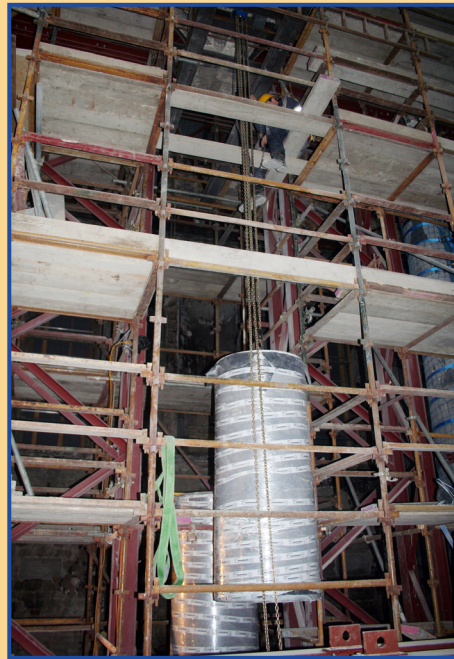
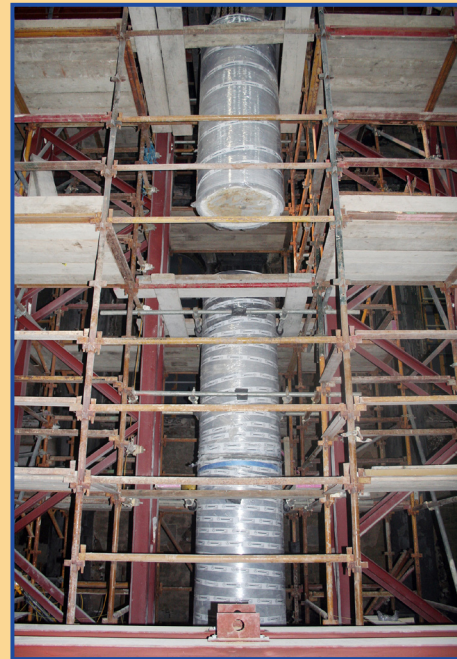
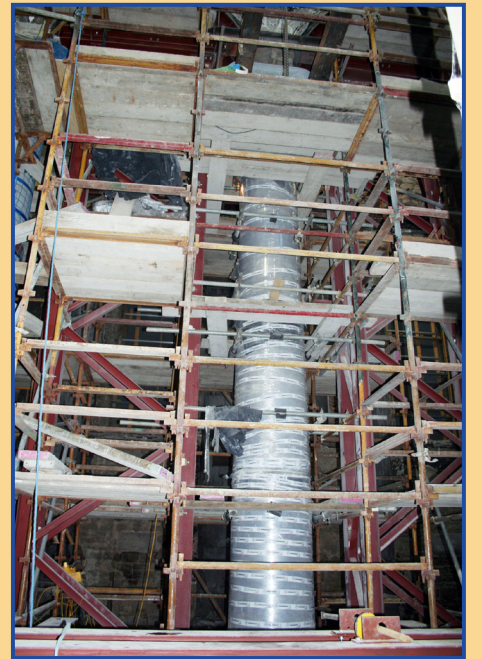
According to workmen the method used in the 1840-92s was not much different to how they worked in 2011.

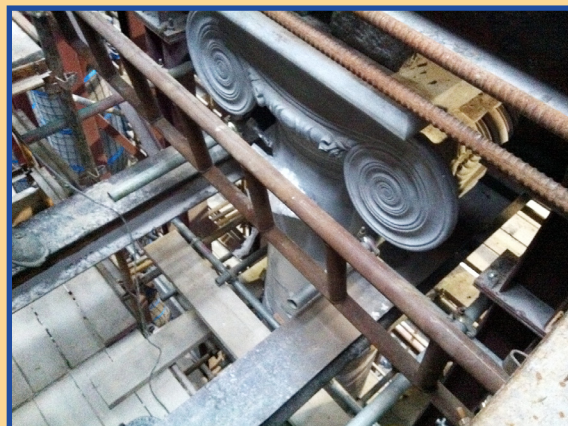
The final piece is put in place as the Ionic Capital stone is lowered and secured.

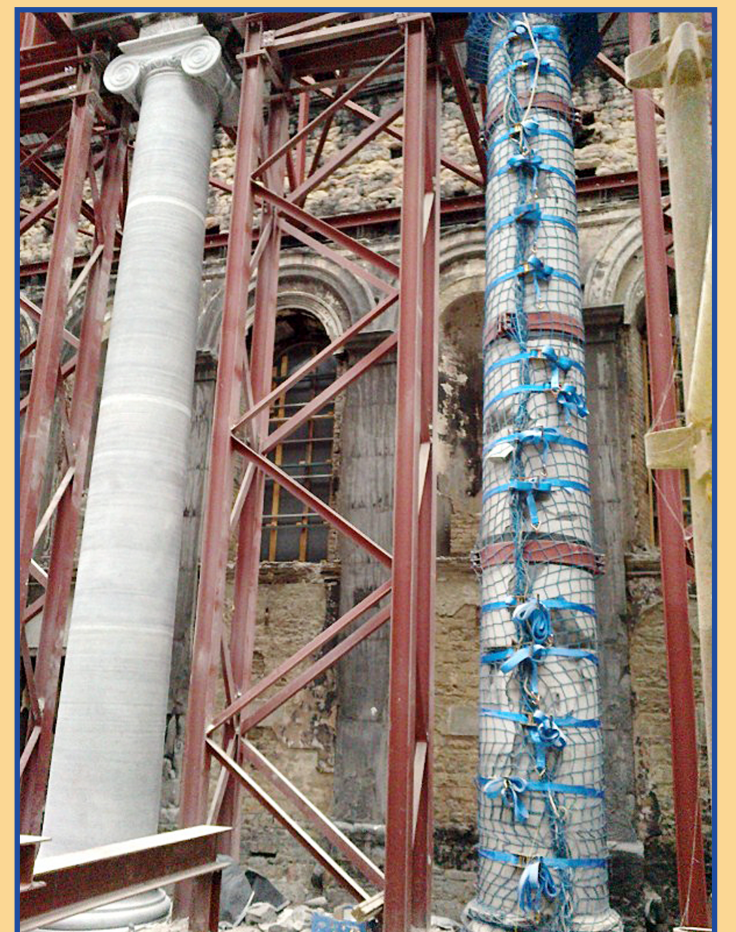
Picture shows the replica pillar in place alongside fire damaged pillar.
